# Sealing the zone between soil and rock to stop water and quick clay

Helen Andersson, PhD, Huth & Wien Engineering AS

**Abstract:** Deep excavations and foundation works performed in soft clay, are known to frequently cause costly damages to neighboring buildings and structures. In 2012, the Norwegian Research Council, NGI, and 22 partners funded a research project called "BegrensSkade". The project aimed to identify possible causes for damages due to building activity, and by increasing the knowledge about these mechanisms also reduce risks for such damages ahead.

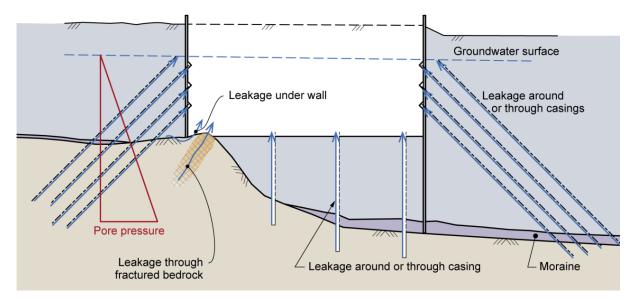
Figure 1 Possible leakage situations for a deep excavation in soft clay [2]

During "BegrensSkade II" the studies on how to execute deep excavations in a safe manner for the surroundings continued. "Byggegropveiledningen", a guideline on different aspects of excavations and foundation works, with contributions from experts in the Norwegian building industry, was published in 2019. Figure 1 illustrates possible leakage situations for deep excavations in soft clay ground.

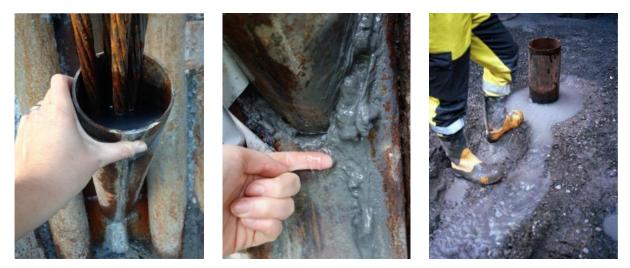
Measures to deal with water leakage through the bedrock, include cement grouted curtains to adequate depths around the pit and/or install infiltration wells before the excavation. Figure 2 shows leakage paths that are typical in a pit; a) water flowing out of the casing for a strand anchor, b) leaks through the holes taken in the sheet pile wall, and c) water causing erosion around the casing for a steel core pile.

Figure 2 Typical leakages in connection with installing tie-back anchors and steel core piles [2]

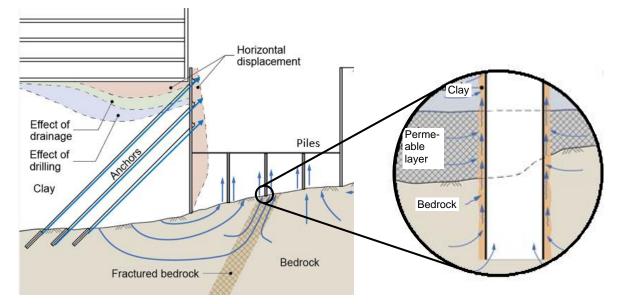
Figure 3 below illustrates the main causes of settlements for an excavation, and the detail to the right focus on the gap along the casing pipe due to overcoring. The reason for overcoring is discussed in detail in [2] – the erosion of soil can stem from 1) suction around the drill bit (which can lead to removal of excessive amounts of silts and sands), 2) collapse of bore hole (local ground failure), and 3) flushing with air and/or water along the drill string (casing) during drilling (or natural ground water flow).

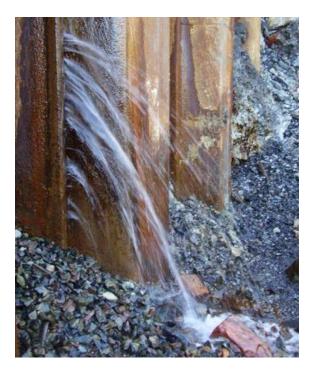
Figure 5 Typical water leakage in interlocks

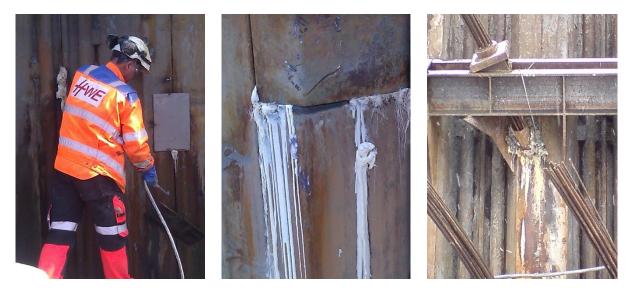
Virtually the same method is used for sealing of holes for anchors in sheet pile walls. To facilitate easier sealing, simple rags and shreds are pushed in place around the anchors. Polyurethane is grouted behind the sheet pile around the anchors, and after contact with water the polyurethane reacts in the gaps around the anchor. The time before the reaction starts after water contact – induction time - is set by use of a catalyst. It is chosen based on the magnitude of water flow, and desired grout propagation.

Figure 6 Sealing sheet pile interlocks and openings by grouting water reactive polyurethane HAG

Leaking sheet pile locks are sealed by grouting water reactive polyurethane into the locks after the sheet piles have been installed. This method is an effective alternative compared with more work-and time-consuming methods, *e.g.* welding.

The procedure is simply to 1) drill a small borehole into the sheet pile lock, 2) install a packer in the hole, and 3) grout polyurethane into the locks by use of a small membrane pump. The grout then follows the interlock, reacts with water, expands, and seals it against future water leakage.

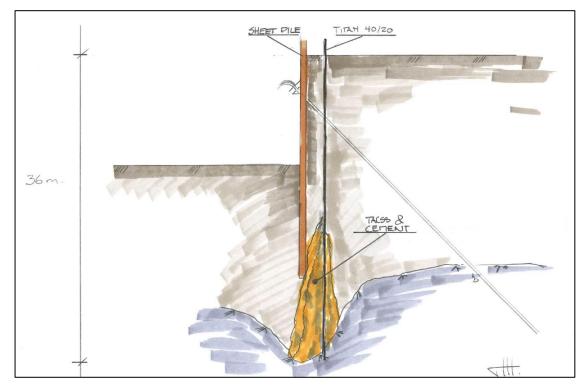
The method HWE uses to seal the gaps between bedrock and the foot of the supporting wall is to drill TITAN 40/20 hollow bars and grout through these pipes in a downstage grouting process. The grouting can be performed with cement, water reactive polyurethane, or a combination of the two (see fig. 7). We have long experience of this method, which we have used since the beginning of the 90's. This method is also used to seal leakages along casings for piles or geothermal installations.

Figure 7 Typical profile of gap between the bedrock and the toe of the sheet pile wall

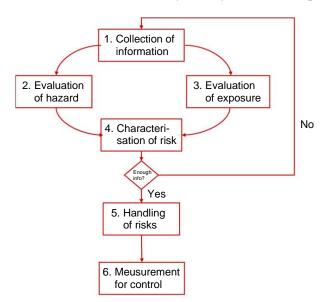
**Figure 8** Methodology – environmental risk evaluation [3]

In connection with a project in the center of Drammen, for sealing around a casing for a geothermal installation to prevent future sink holes, COWI Aquateam performed an environmental risk assessment [3]. The methodology used when performing an environmental risk evaluation is shown in figure 8.

First, easily available information is collected, and an assessment is made about the potential hazards and exposure. The risk is then characterised based on this initial information. If the risk is limited, it is not necessary to gather any more information or decide on measures to handle the risks, and the risk evaluation can be finalised. Such an initial screening of the environmental risk uses conservative values and high safety factors, detailed information is not collected, and the analysis may be rather simple.

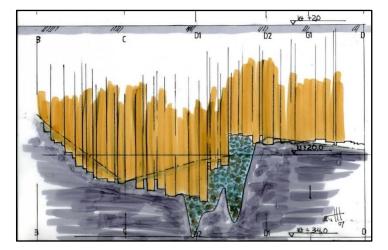
Figure 10 Illustration of false stops in the moraine [6]

Figure 10 illustrates gaps where the sheet piles had been driven to false stops before reaching bedrock.

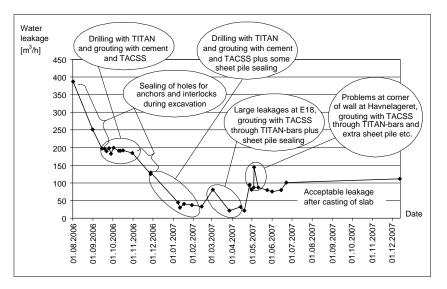
The response on the water flowing into the excavation, after the grouting performed on many different leakages, between August 2006 and December 2007, is shown in figure 11.

Figure 11 Water leakages to the building pit at Havnelageret [6]

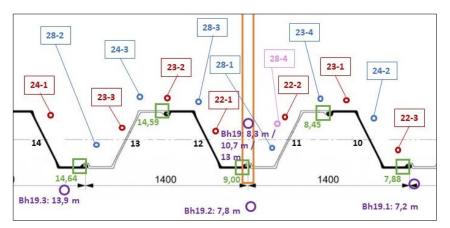
Figure 12 Placement of grout holes in two rounds, *i.e.* split spacing

After driving the sheet pile wall, the situation had been preliminary drawn up with depths. The planning of the grouting, for placement of grout holes etc., was based on this information.

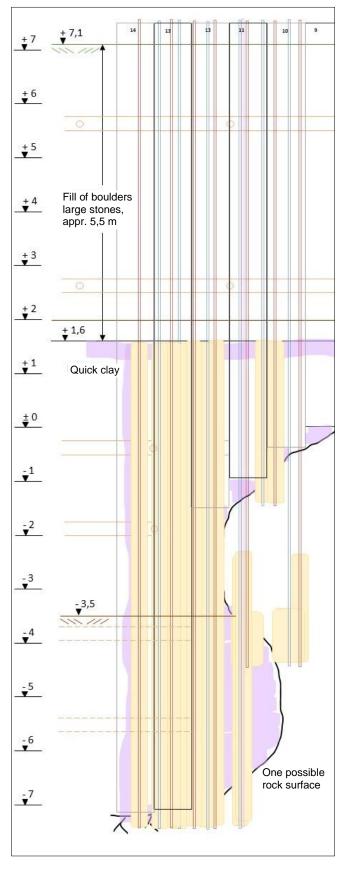
Figure 13 Theoretical placement of polyurethane grout

The drilling of the hollow bars had to be performed by use of water through the fill in the upper 5,5 m (see fig. 13). Both, the drilling through the fill of large stones was easier to perform with water flushing, and also the consumption of polyurethane was dedicated for strengthening of the clay.

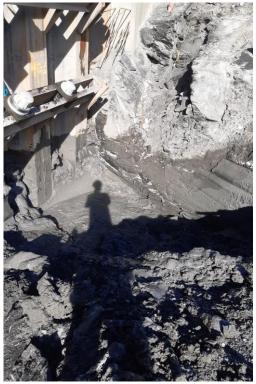
In figure 14 below, the polyurethane can be seen in the clay below the protruding rock. The grouted quick clay was stable and steel plates could be welded on from the back of the sheet pile to the bedrock.

Figure 14 Polyurethane mixed with clay
