Sealing the zone between soil and rock to stop water and quick clay

Introduction on polyurethane grout

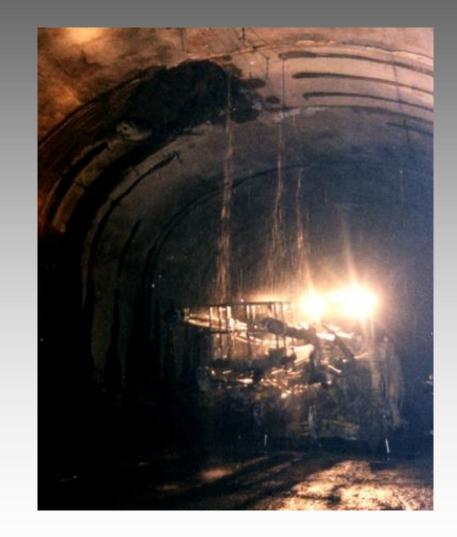
Environmental aspects for polyurethane

- Environmental risk assessment Romeriksporten, Oslo
 - use of all chemical grouts was stopped due to the Rhocagil scandal
 - very high requirements were set on health and environmental aspects
 - investigation and information seeking led to trial grouting rounds with PU
 - water measurement program and calculations controlled the pollution

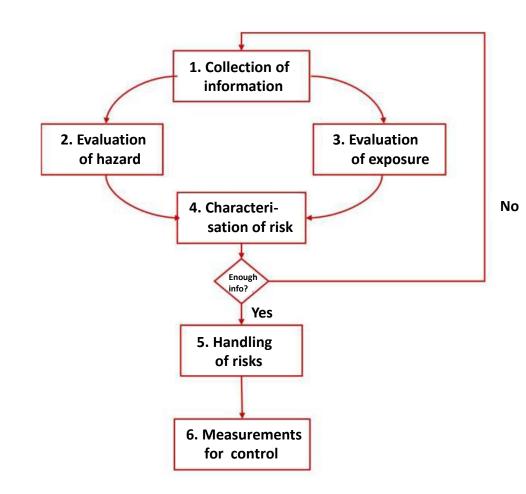
Environmental aspects for polyurethane

- Environmental risk assessment typical methodology
 - initially low detailing combined with very high safety factor
 - risk characterisation may require collection of additional data
 - larger information base allows a lower safety factor to be used
 - unwanted risk is handled and pollution is controlled

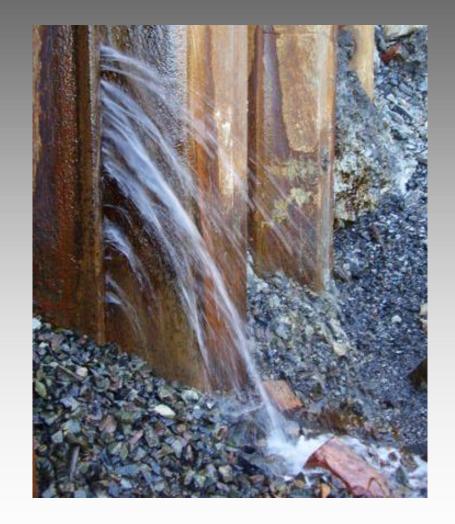
Pore pressure reduction

- drilling for tiebacks and/or piles, through casing or along drill string
- holes in sheet pile and/or interlocks
- gaps between bedrock and toe
- joints and fissures in bedrock

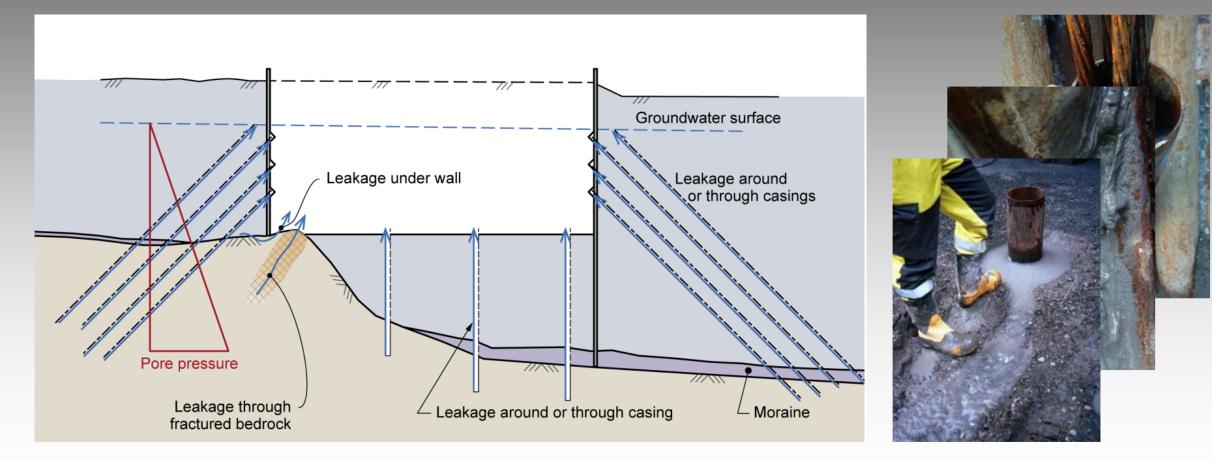
Grouting to seal a sheet pile wall

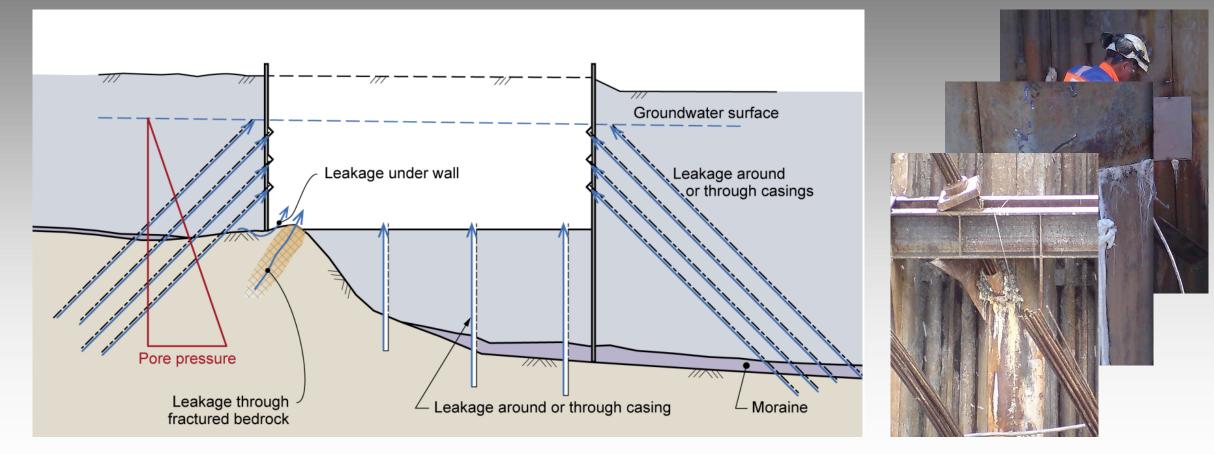
Grouting to seal a sheet pile wall

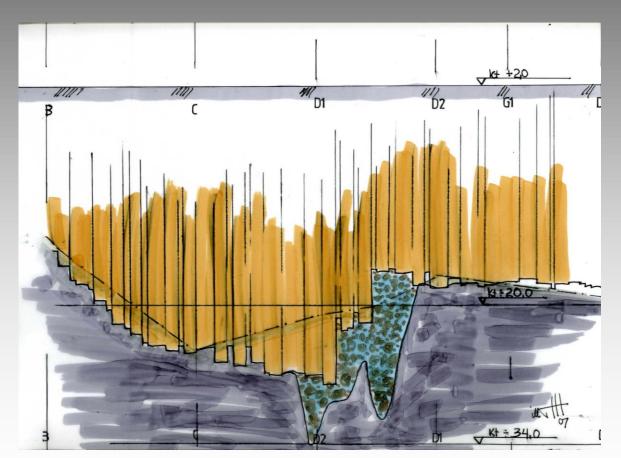
Grouting to seal gaps below a sheet pile wall

- illustration Havnelageret, Oslo, gaps between toe and bedrock
- false stops of sheet pile in hard permeable moraine with blocks
- in some places more than 10 m between sheet pile and bedrock
- large water leakage into the building pit despite jetgrouting

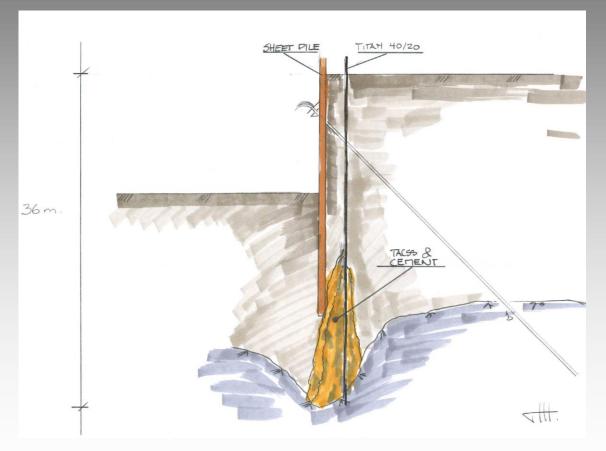
Havnelageret, Oslo

Sealing against water ingress

- primitive but effective sealing with PU of holes for tiebacks in and interlocks the sheet pile
- drilled to more than 30 m depth with TITAN 40/20 hollow bar and performed combination grouting
- Combi Grouting is a downstage grouting method where PU is added to the cement grouting

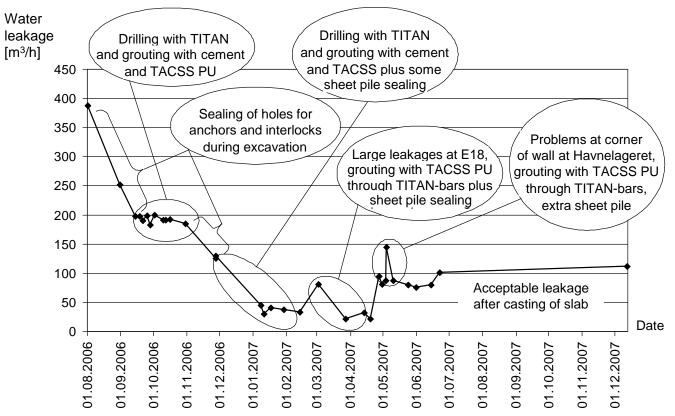
Havnelageret, Oslo

Sealing against water ingress

- polyurethane grouting to seal holes for tiebacks and interlocks in the sheet pile
- combination grouting with polyurethane and cement to seal below sheetpile toe
- water leakage ~400 m³/h to $\sim 50 \text{ m}^3/\text{h}$ (excavating), ~100 m³/h ok with slab

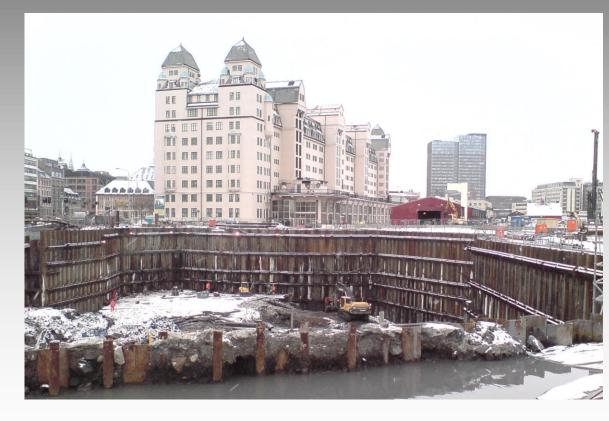
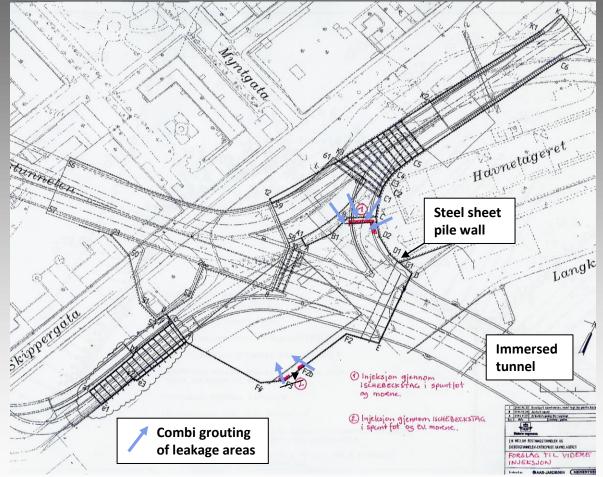
Havnelageret, Oslo

Sealing against water ingress

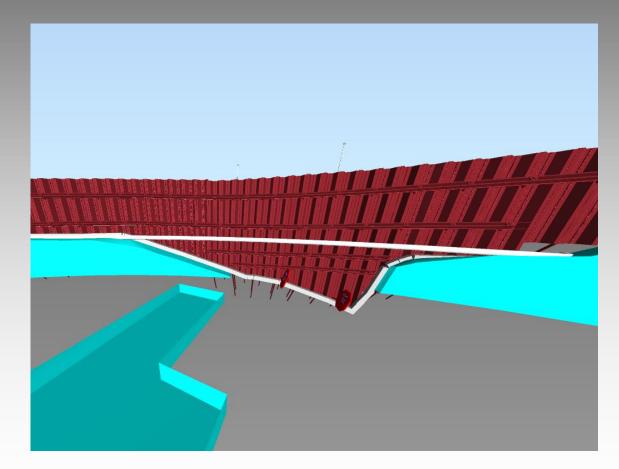
Fornebubanen K4, Oslo

Anchor rows Bolts H≈5,5m Bolts H≈5,5m Bolts Possible bedrock shape(s)

- polyurethane grouting have been used a couple of times to prevent quick clay
- a large deviation discovered when installing the sheet pile, bedrock at 7 m and 15 m depth
- planning of the grout efforts was made unnecessarily difficult by the 3D-model

- polyurethane grouting have been used a couple of times to prevent quick clay
- a large deviation discovered when installing the sheet pile, bedrock at 7 m and 15 m depth
- planning of the grout efforts was made unnecessarily difficult by the 3D-model

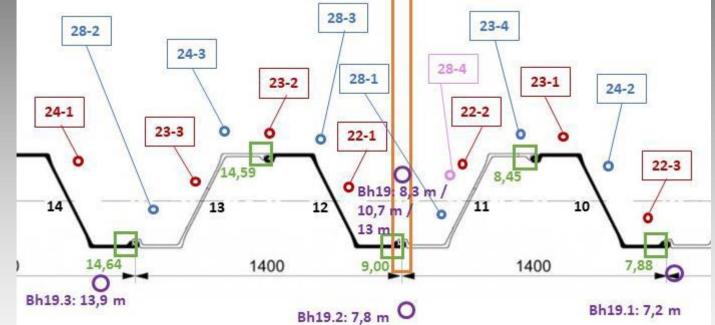
- Fornebubanen K4, Oslo
 - grouting with polyurethane to prevent inflow of quick clay during excavation
 - placement of grout holes for two grouting rounds, *i.e.* split spacing
 - decisions also made from observations from drilling of the hollow bars

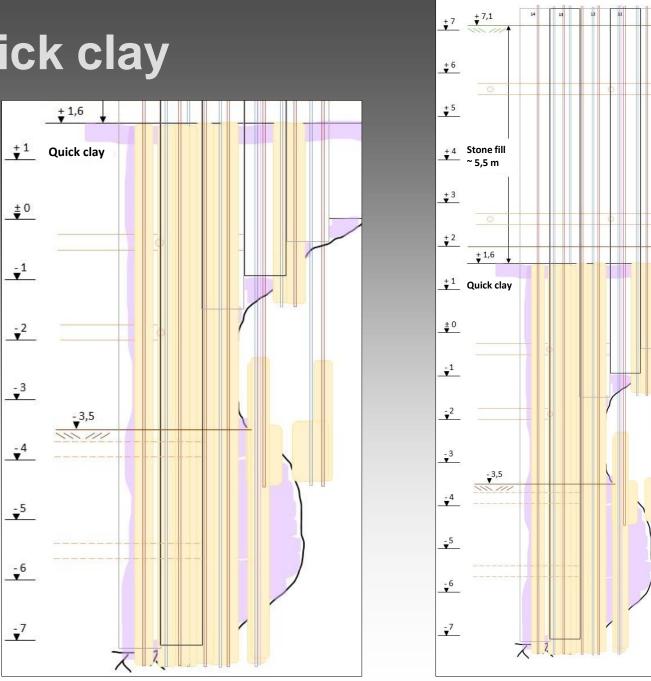
- Fornebubanen K4, Oslo
 - drilling with water flushing through the upper 5,5 m stone fill to save PU
 - drilling to, or through, the rock "shelf" to investigate, retracting before grouting
 - important to seal also the possible inflow of quick clay at 9 m full height

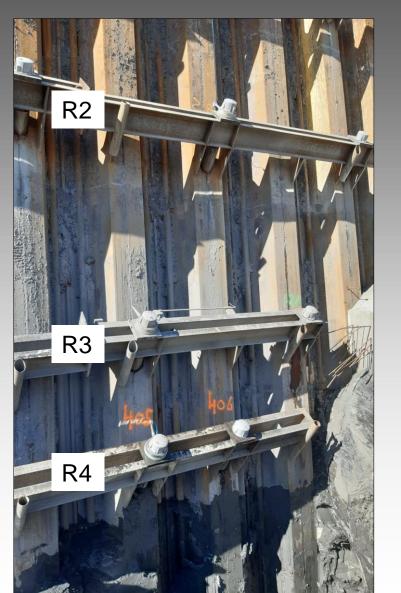
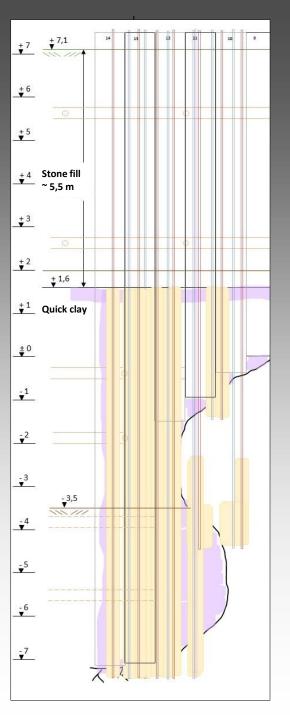
- Fornebubanen K4, Oslo
 - drilling with water flushing through the upper 5,5 m stone fill to save PU
 - drilling to, or through, the rock "shelf" to investigate, retracting before grouting
 - important to seal also the possible inflow of quick clay at 9 m full height

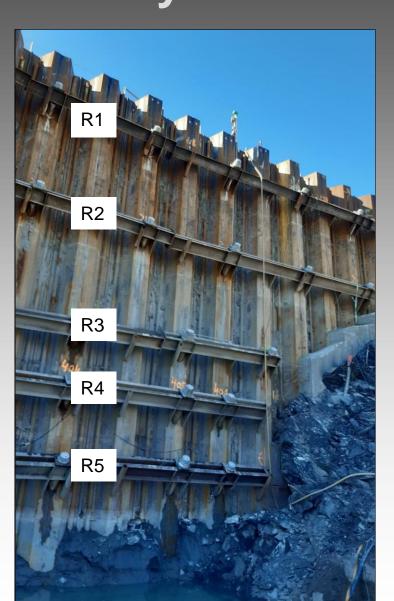
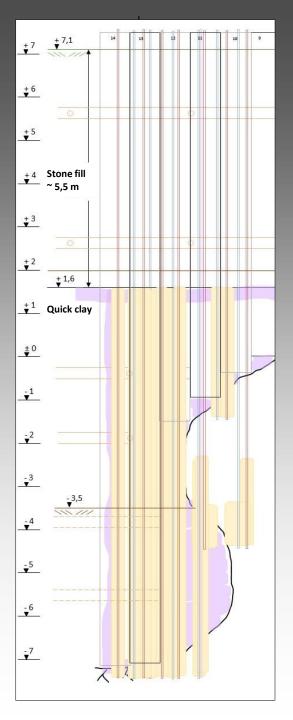
- Fornebubanen K4, Oslo
 - drilling with water flushing through the upper 5,5 m stone fill to save PU
 - drilling to, or through, the rock "shelf" to investigate, retracting before grouting
 - important to seal also the possible inflow of quick clay at 9 m full height

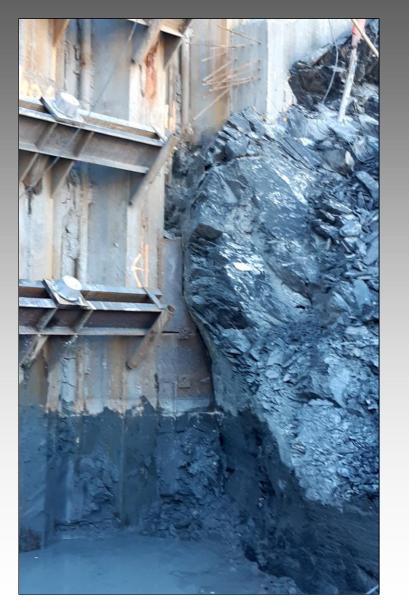
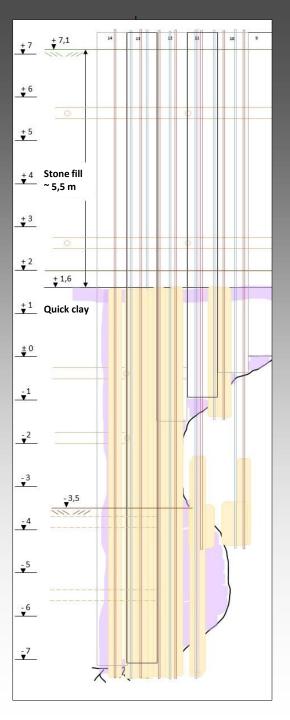
- Fornebubanen K4, Oslo
 - drilling with water flushing through the upper 5,5 m stone fill to save PU
 - drilling to, or through, the rock "shelf" to investigate, retracting before grouting
 - important to seal also the possible inflow of quick clay at 9 m full height

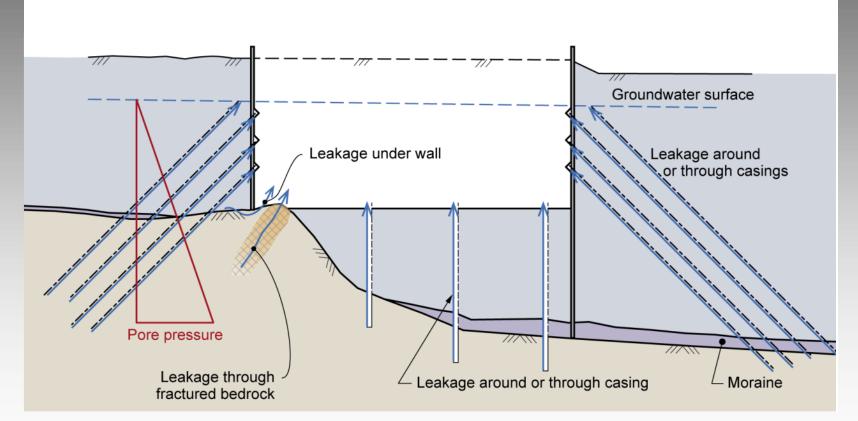
Limit damages due to deep excavations

- In summary
 - BegrensSkade
 identified different
 causes of damage
 - polyurethane can handle the sources of settlements, but beware of silt
 - environmental risk evaluation may be required, or not
